Nepal: Responding Proactively to Glacial Hazards

World Resources Report Case Study

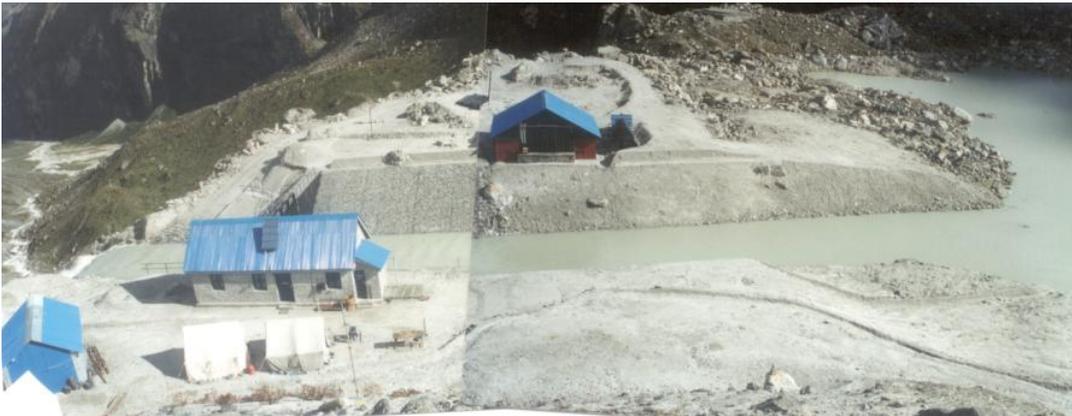
Figure 3: Open channel constructed in Tsho Rolpa (Source: Arun Shrestha)

In August 1997, a team which included international and national experts visited the lake and recommended lowering the lake level by 3 m by cutting an open channel in the southwest part of the end moraine (DHM, 1997). The Netherlands government funded this project, for which a grant agreement for the Tsho Rolpa Glacial Lake Outburst Flood Risk Reduction Project was signed in August 1998 between the Netherlands and the Government of Nepal. The objective of the 3 m lake lowering was to reduce the water level, which would immediately and tangibly reduce the risk of a breach forming in the natural moraine dam. This flood risk reduction system consisted of a lined channel constructed through the western end moraine (DHM, 1998). The work was 90% complete when construction was halted for the winter shutdown in October 1999 (DHM, 2000). The construction work began again in April 2000 and was completed by the middle of July 2000, lowering the lake level by 3 m (See Figure 3).

construction of a gated open channel on the moraine for controlled release of lake water to lower the lake level by 3 m. The lowering of the lake was conducted with support from the government of the Netherlands (Dahal, 2008). The construction was completed in 2000.

The structure constructed to lower the lake level at Tsho Rolpa is still perfectly functional. It is believed that the efforts to lower the lake averted the immediate glacial lake outburst flood risk. The water flowing out of the open channel was tapped to run a small micro-hydro plant that has been powering the site, which is manned throughout the year, securing the energy sustainability of the project (Arya, 2007).
